Soil Survey for Onsite Septic Systems

Project Number: 2310.06
Date of Survey: 10-18-2023
County Health Department: Morgan
Phone: 765-342-6621 Email: bknieriem@morgancounty.in.gov
Purpose of Analysis: New Construction

SITE SKETCH
 E Ridge Rd
 Martinsville, IN 46151

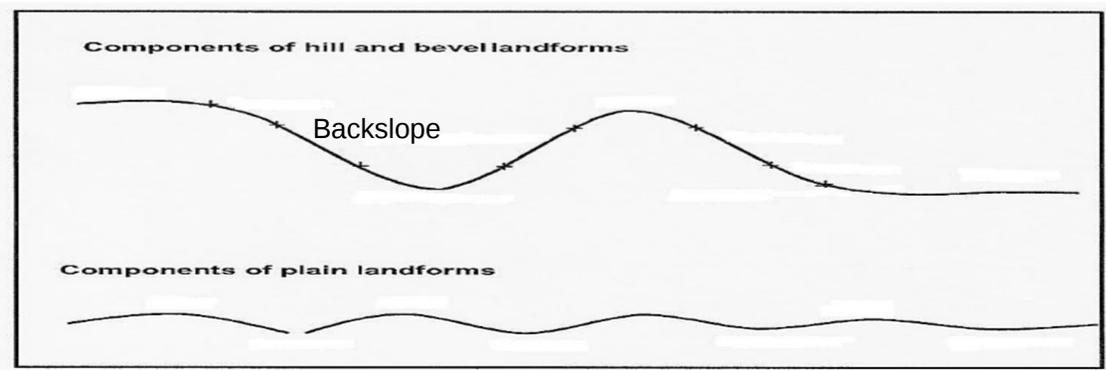
Relative Position of Soil Borings:

- Site Comments:** The property is being subdivided into additional lots.
 The building site is located on a hilltop. A walkout basement is planned.
 A water well is present on the site. A ditch exists on the property.
